Whole House Inspection Report

May 10, 2026

**444 Ready Report Test Drive, AnyTown, CO
78704**

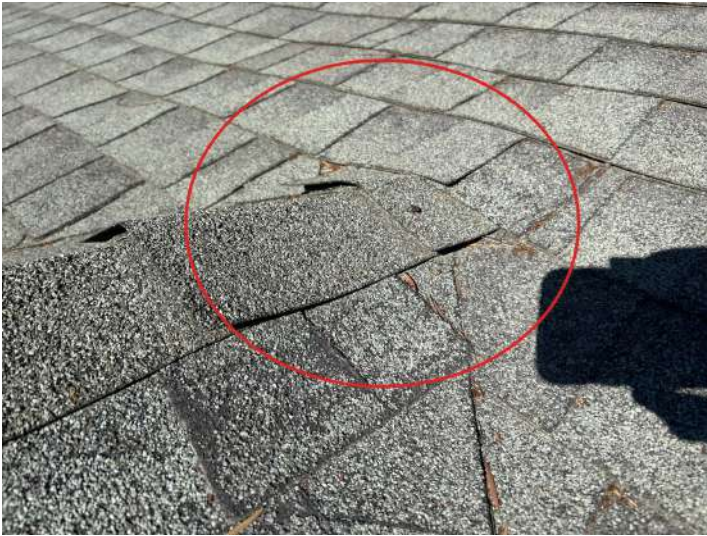
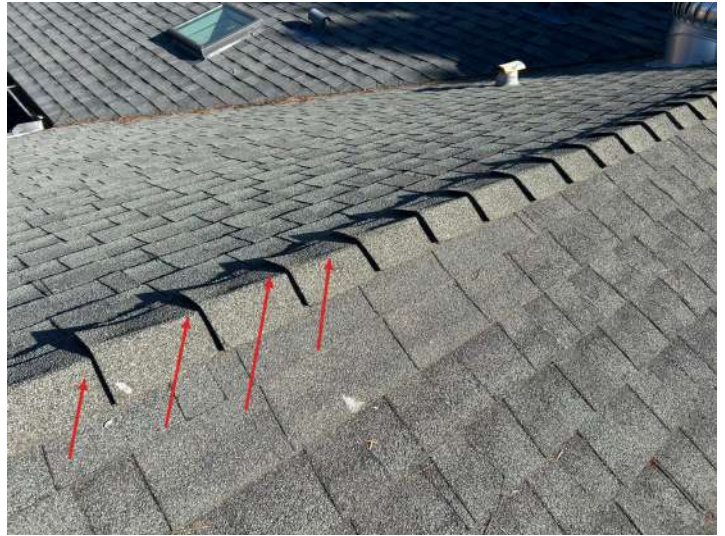
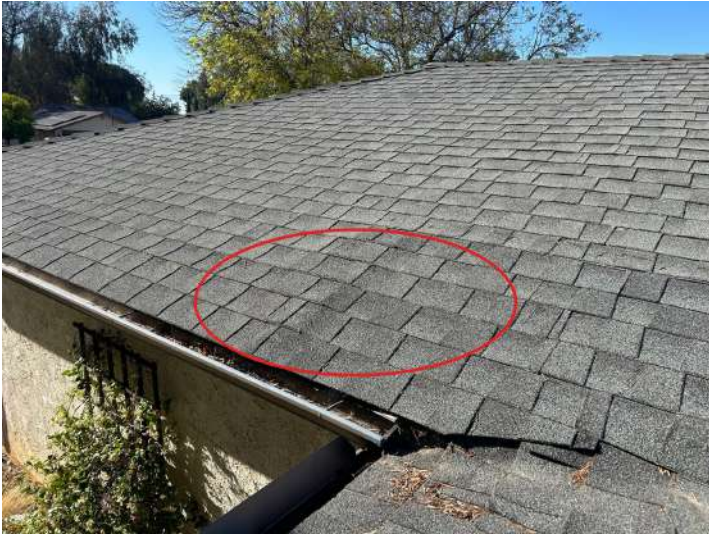
Roof-covering materials

Defects: Damaged shingles; Damaged/missing shingles; Surface deterioration

Notes: Damaged and lifted shingles were observed at the ridge line. Shingles appear to be installed in at least two layers and are reaching the end of their lifespan. Some lifting was observed hinting at possible water damage at some point.

Evaluation and correction by a qualified professional is recommended.

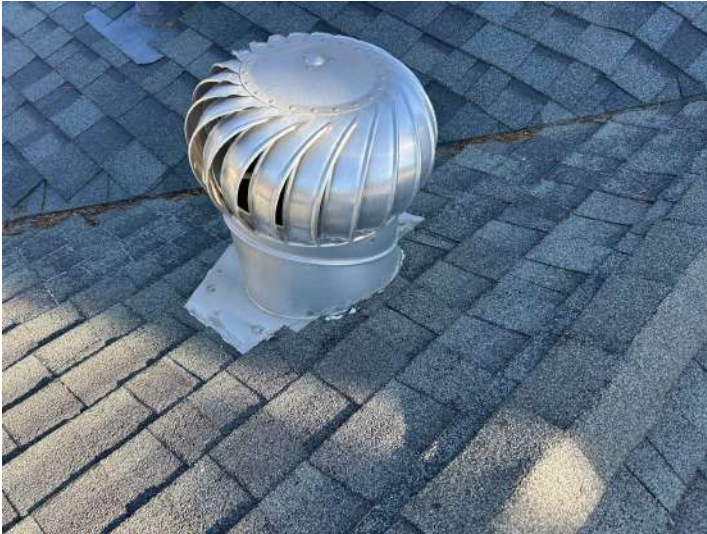
Photo 1.3A - Vents, flashing, skylights, chimney & penetrations

Notes: Vents, flashing, and skylight were in good condition.

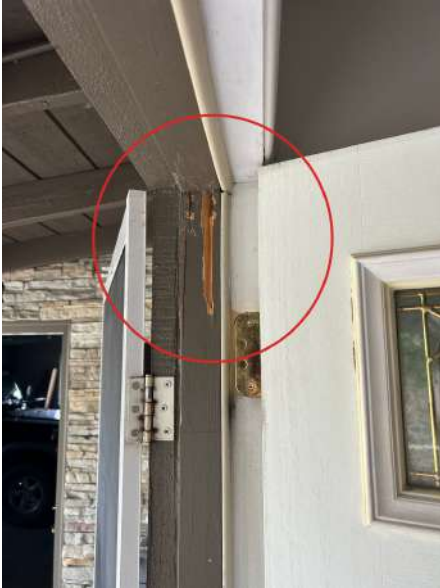
Photo 2.4A - All exterior doors

Defects: Frame damage/rot

Notes: Front door had some cracking

Evaluation and correction by a qualified professional is recommended.

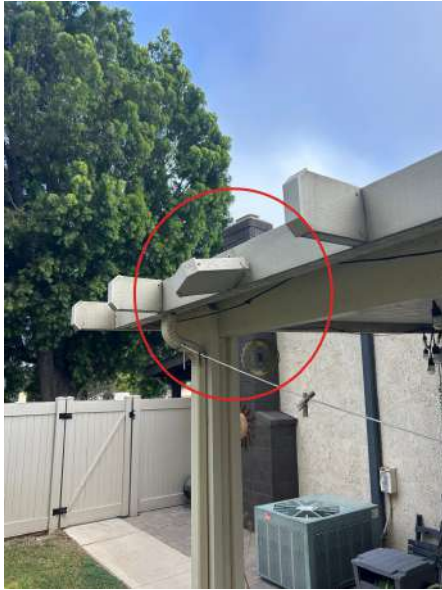
Photo 2.7A - Porches, patios, decks, balconies & carports

Notes: patio cover needs repair on one of the decorative eaves.

Evaluation and correction by a qualified professional is recommended.

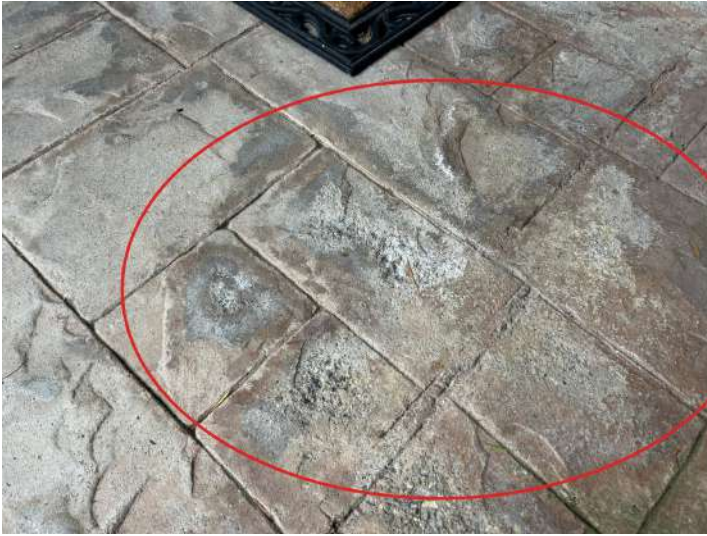
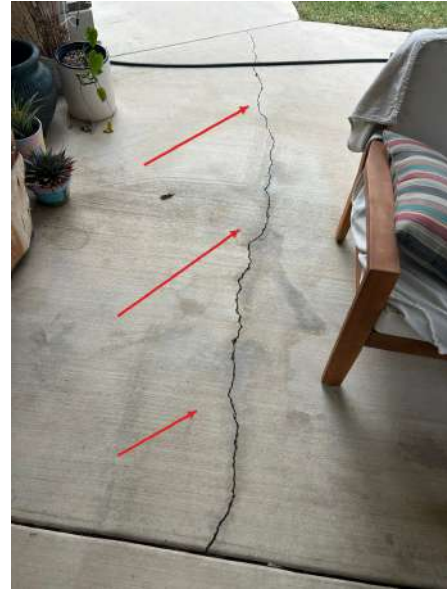
Foundation

Defects: Efflorescence; Cracking observed; Settlement evidence

Notes: Slab-on-grade foundation observed. Signs of efflorescence were noticed around the outside front of the house. Cracking in the concrete on both patios was noticed from settlement.

Evaluation and correction by a qualified professional is recommended.

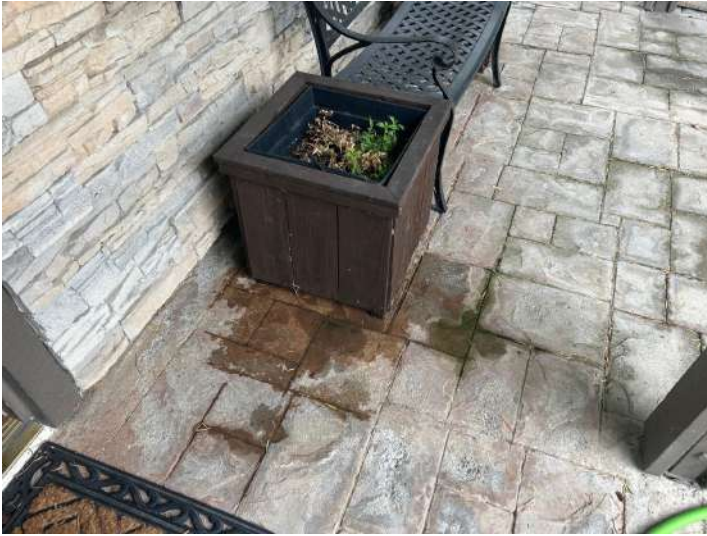
Photo 3.6A - Active water penetration

Foundation, Basement & Crawlspace - Standing water present standing water was present in the front of house indicating poor drainage and slope towards house. Also presence of a sprinkler in the plants was responsible for dropping too much water, too often.

Evaluation and correction by a qualified professional is recommended.

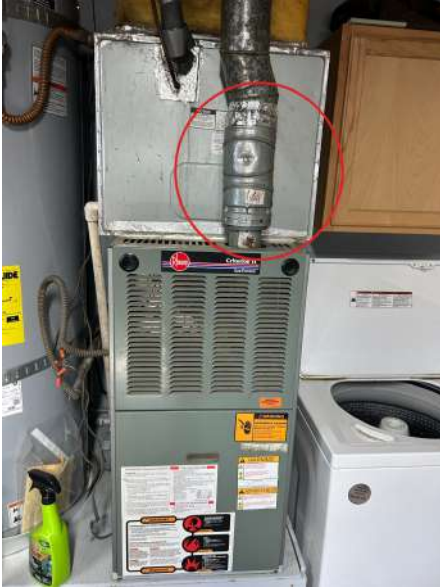
Photo 4.1A - Heating system — operated via normal controls

Defects: Unusual noise observed

Notes: System responded to normal controls. However Heater blower bearings were squeaking. The age of the unit 1998 is a concern as it is past its lifespan. Exhaust is installed incorrectly.

Monitor, maintain, or plan improvement as part of normal ownership.

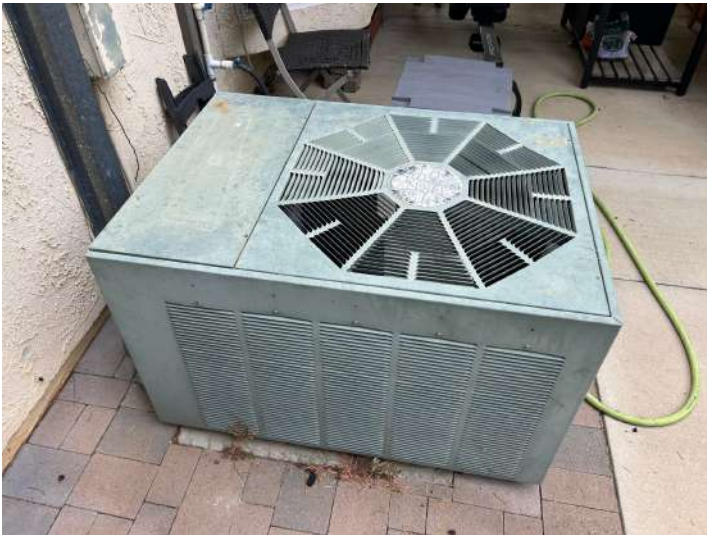
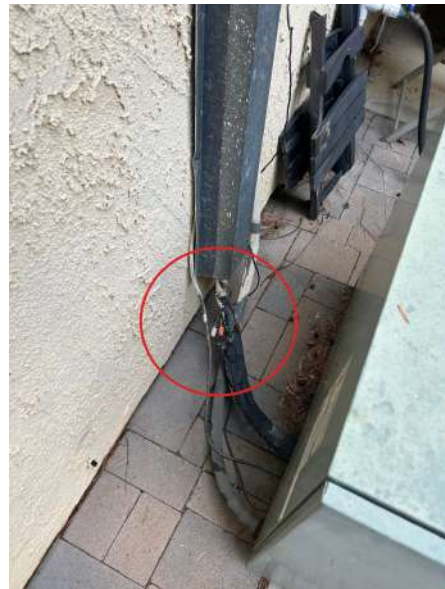
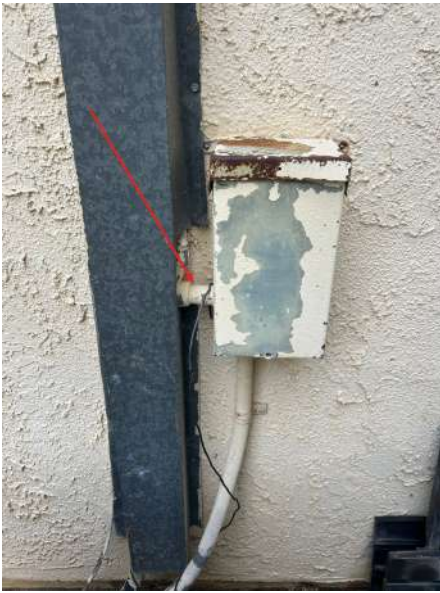
Cooling system — operated via normal controls

Notes: System responded to normal controls. However it is an old system and past its intended lifecycle. Exposed wires were noticed behind the unit.

Evaluation and correction by a qualified professional is recommended.

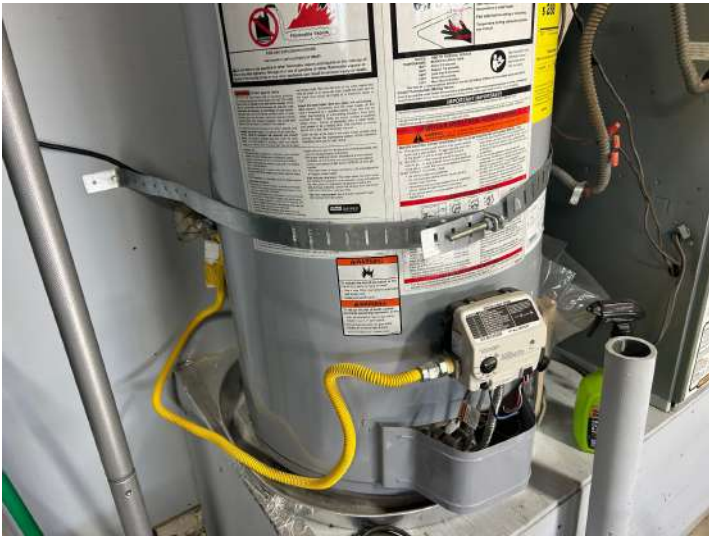
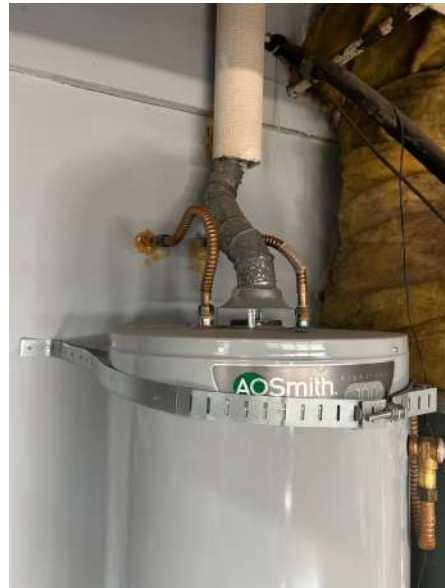
Water heater — energy source, venting, TPR valve, seismic bracing

Defects: Aging equipment

Notes: Seismic bracing was installed as well as a drain pan.

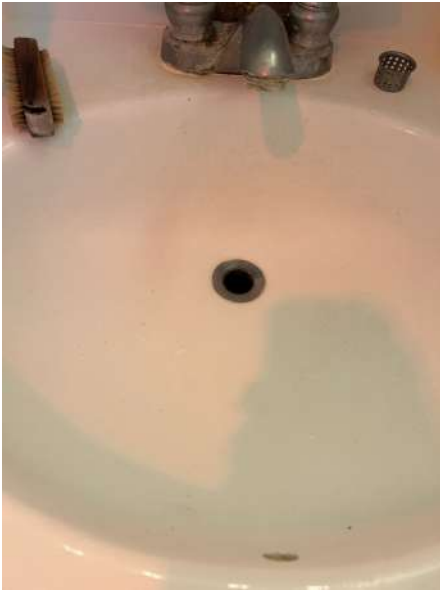
Photo 6.6A - All sinks, tubs & showers — functional drainage

Defects: Stopper inoperable

Notes: Master sink stopper is missing.

Evaluation and correction by a qualified professional is recommended.

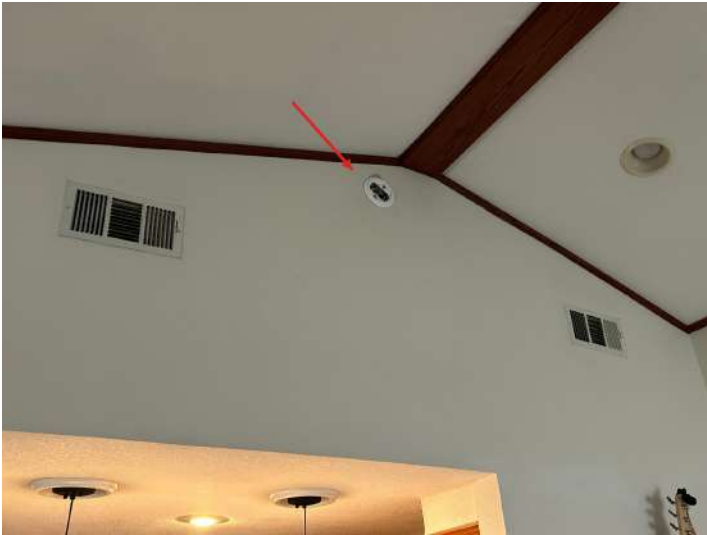
Photo 7.10A - Smoke & CO detectors — presence verified

Defects: Smoke detector absent

Evaluation and correction by a qualified professional is recommended.

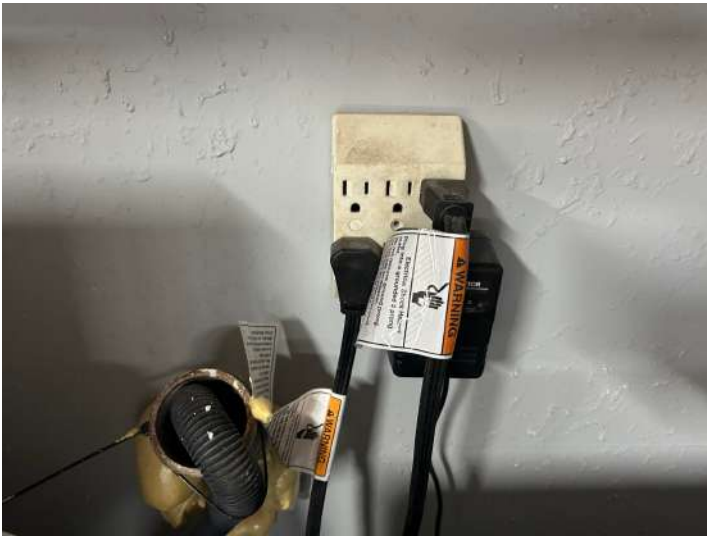
Photo 7.14A - Receptacle deficiencies

Notes: Overloaded outlet in laundry room

Evaluation and correction by a qualified professional is recommended.

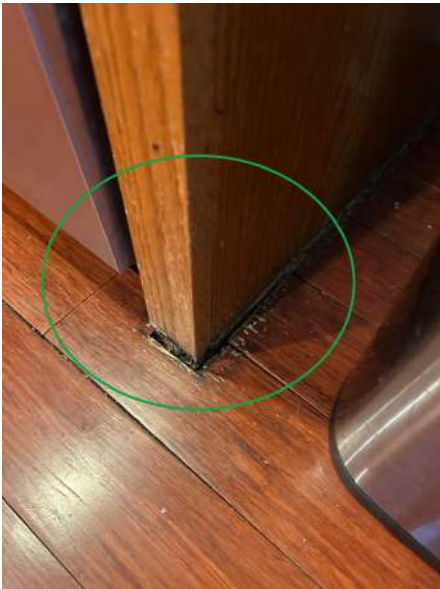
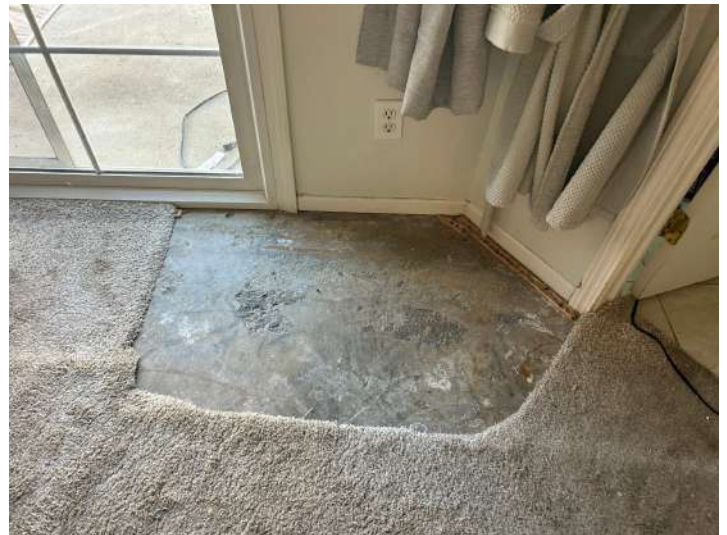
Floors, walls & ceilings

Defects: Water staining observed

Notes: Water damage on the kitchen floor by dishwasher. Mold may be present and should be looked at by a professional. Carpet was missing in the master bedroom. Seller explained that a pet ruined it.

Evaluation and correction by a qualified professional is recommended.
